**Flood Control Project Maintenance
Levee Inspections****LMA District Cover Sheet****Spring 2011 Levee Inspection Results****Levee District No. 0001 (Glenn County)**

Levee Inspection Report By Mile - Spring 2011

Levee District No. 0001 (Glenn County)

Waterway						Bank	Unit Miles	Inspection Start/End	Inspector
Unit No. 01 Sacramento River						Right	12.45	03/23/2011 03/23/2011	Bob Duffey

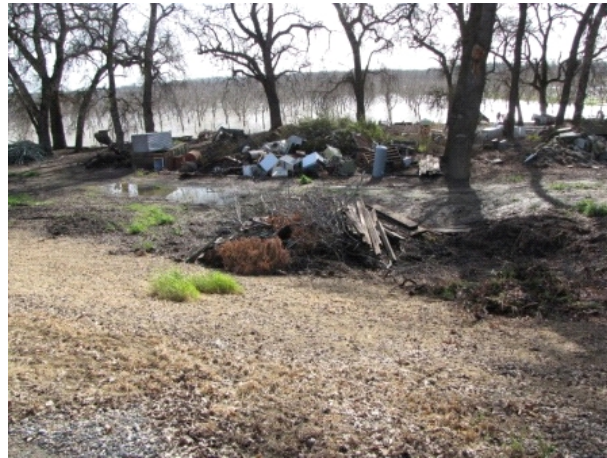
rduffey_s_20110427_283.jpg

Levee Mile Report Line	3
Start Levee Mile	1.23
End Levee Mile	1.23
Location	Water Side
Category	Earthen Levee
Item	Encroachments

View of the debris & garbage along the W/S toe.

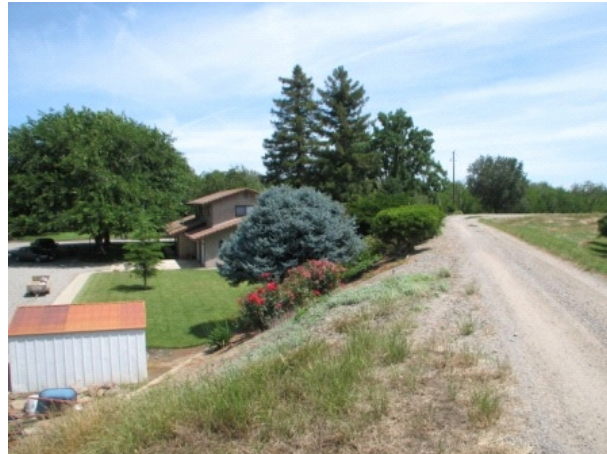
rduffey_s_20110228_001.jpg

Levee Mile Report Line	4
Start Levee Mile	1.35
End Levee Mile	1.39
Location	Land Side
Category	Earthen Levee
Item	Encroachments

View of the permitted landscape on the landside slope of the levee.

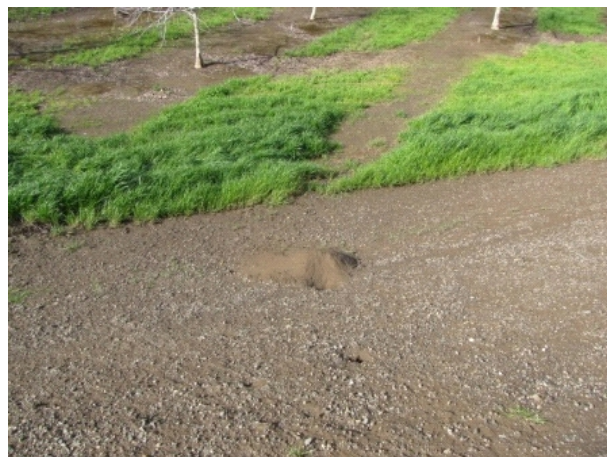
rduffey_s_20110427_284.jpg

Levee Mile Report Line	9
Start Levee Mile	3.13
End Levee Mile	3.13
Location	Land Side
Category	Earthen Levee
Item	Animal Control

View of the rodents burrows along the slope.

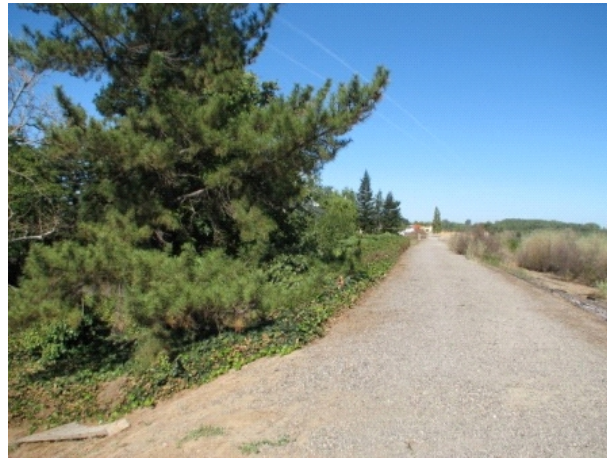
rduffey_s_20110228_003.jpg

Levee Mile Report Line	21
Start Levee Mile	6.39
End Levee Mile	6.42
Location	Land Side
Category	Earthen Levee
Item	Encroachments

View of the permitted landscape along the landside slope.

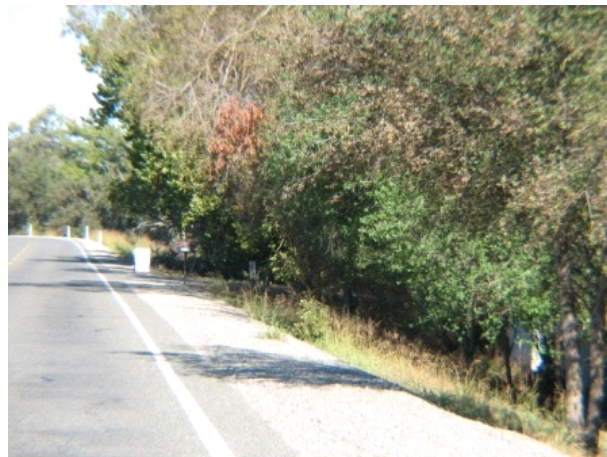
rduffey_s_20110228_004.jpg

Levee Mile Report Line	24
Start Levee Mile	8.17
End Levee Mile	8.28
Location	Water Side
Category	Earthen Levee
Item	Trim / Thin Trees

View of the trees and vegetation along the waterside slope of the levee.

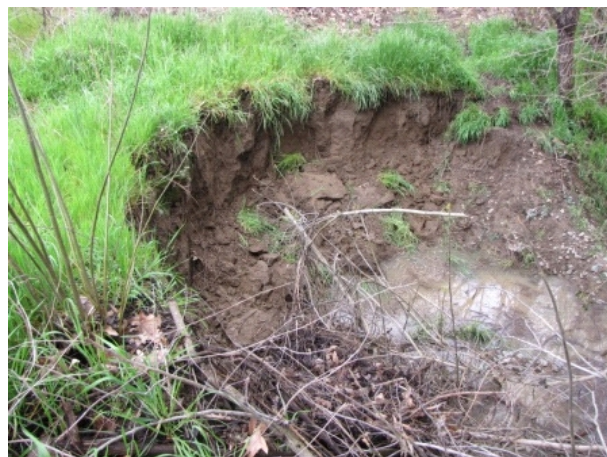
rduffey_s_20110427_286.jpg

Levee Mile Report Line	26
Start Levee Mile	8.96
End Levee Mile	8.96
Location	Water Side
Category	Earthen Levee
Item	Erosion / Bank Caving

View of the erosion from the failed pipe.

25	8.84	9.62	Earthen Levee	Vegetation	WS	C	Remove the wild growth other than native grasses from the levee slopes.	39.585621 ° -122.006738 °	39.595938 ° -122.002652 °	34
26	8.96	8.96	Earthen Levee	Erosion / Bank Caving	WS	U	Schedule repair of erosion site prior to the next inspection.	39.587102 ° -122.005605 °	39.587102 ° -122.005605 °	7 Y
27	9.03	9.62	Earthen Levee	Vegetation	LS	M	Remove the wild growth other than native grasses from the levee slopes.	39.588028 ° -122.005321 °	39.595938 ° -122.002652 °	41
28	9.70	9.70	Earthen Levee	Encroachments	LS	M	Debris	39.597078 ° -122.002127 °	39.597078 ° -122.002127 °	11 Y
29	10.21	10.55	Earthen Levee	Animal Control	LS	M	Exterminate rodents and backfill and compact or grout burrows.	39.603211 ° -121.997176 °	39.607431 ° -121.994458 °	46
30	10.65	10.69	Earthen Levee	Animal Control	LS	M	No rodents visible, but rodent burrows visible; need to backfill and compact or grout burrows.	39.608748 ° -121.993678 °	39.609355 ° -121.993628 °	12

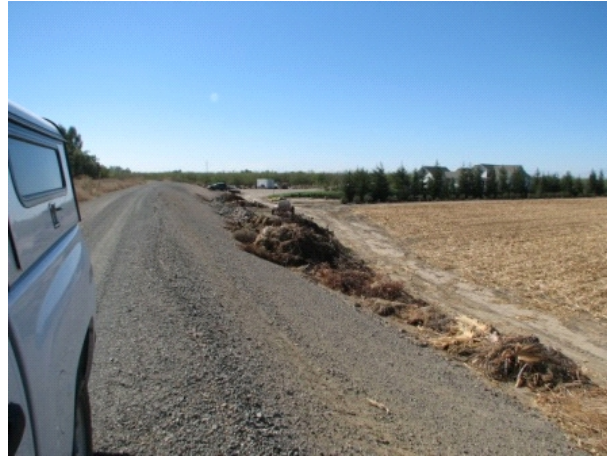
rduffey_s_20110228_002.jpg

Levee Mile Report Line	28
Start Levee Mile	9.70
End Levee Mile	9.70
Location	Land Side
Category	Earthen Levee
Item	Encroachments

View of debris along the toe of the levee.
